**Repairs to Agilent ESG series, signal generator E4421B**  
**Specification = 100KHz to 3GHz, -136dbm to +25dbm**

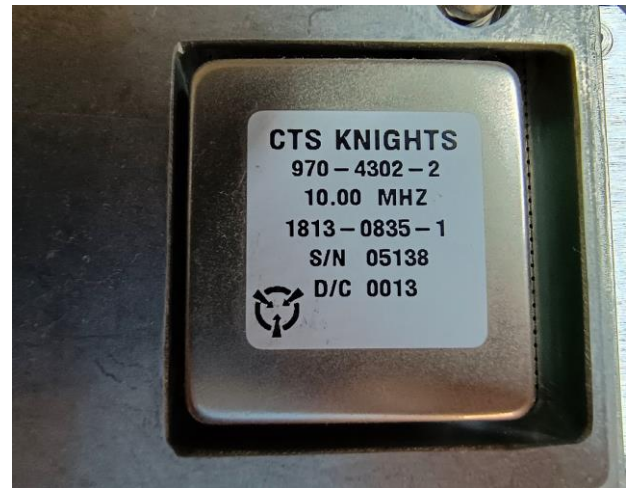
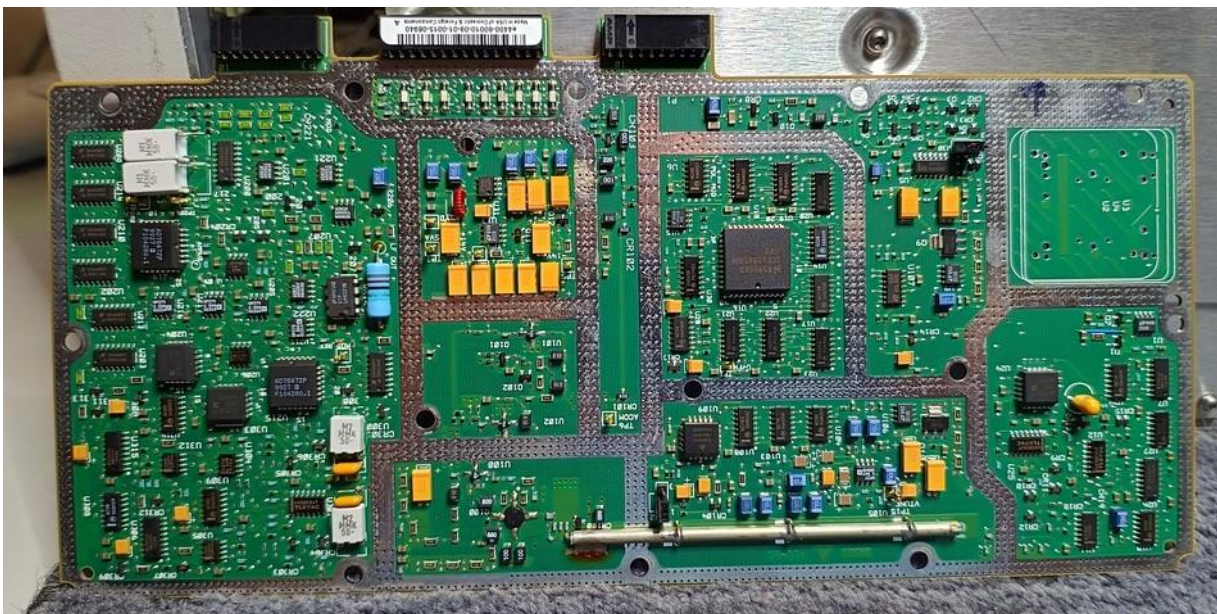
Top left = original diecast encased module, top and bottom.  
Right top = TCXO module.  
Bottom = Reference module with TCXO removed.

After removing the crystal module from the PCB, and setting up a test jig, it showed exactly what I had originally thought, phew!!! Errors of 100-300Hz and not anywhere close to spec at all. Pulling the control pin to ground or 10Vdc (in the actual circuit it could vary from +14V to -14V) again proved the 10MHz was way off by a factor of 10 times worse than any specification. These are pretty specialised and the exact part was going to be a real problem to obtain = likely “Unobtainium” status.

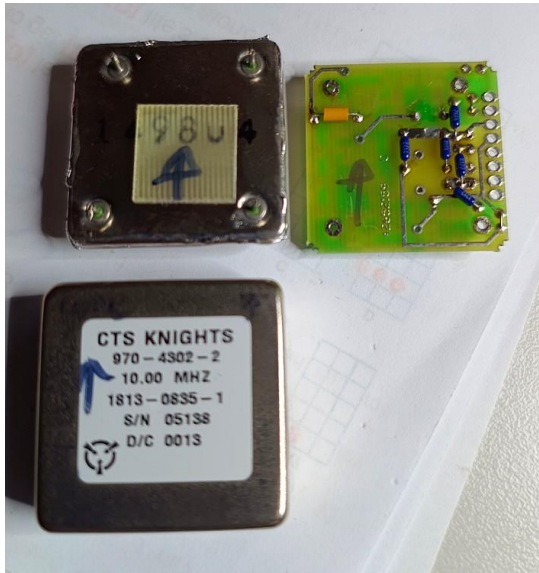
TCXO split apart - with guide arrows to help later on with re-assembly.

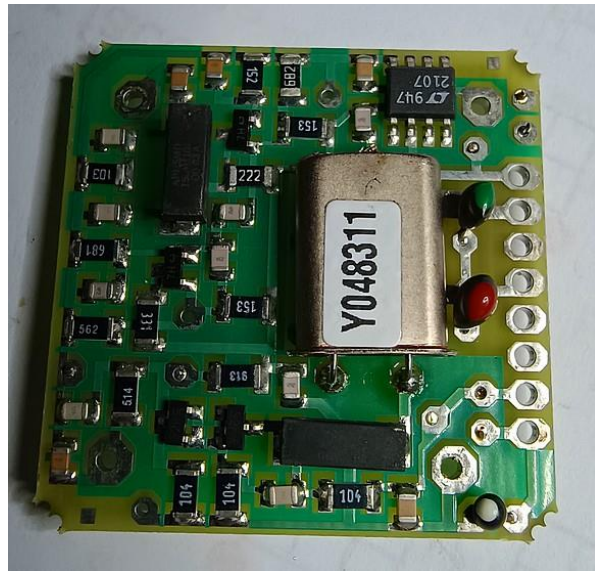
Top view of the TCXO.

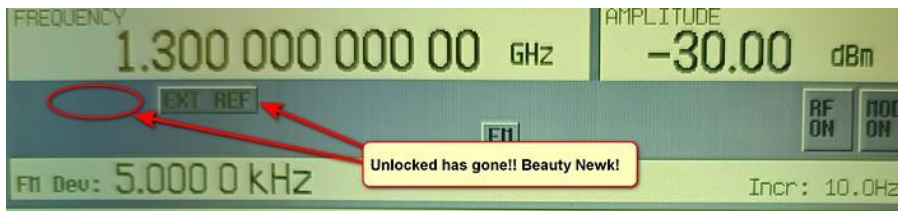
Result above is with everything locked to the external GPS reference and measuring a 3GHz generated CW signal (maximum frequency of the generator) it reveals an error of only 0.36Hz.

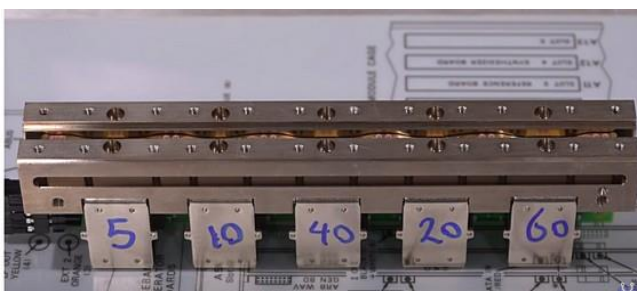
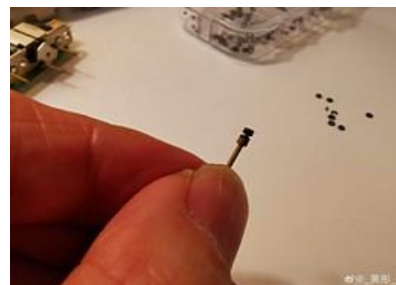
Research pointed to the mechanical attenuators (a high output power option ) which have miniature O-rings that deteriorate, collapse and sometimes fall off inside the attenuator. These can jam the relays or plungers, as well as reduce the plunger travel, causing intermittent and random, sometimes complete failure of certain attenuation steps. Sounds like a perfect fit. (Did I every say ASS0? = Assume nothing!) So I ordered a set of O-rings. Size required was 2mm OD, x 1.8mm ID, by 0.5mm thick. These are really quite minuscule!

But what a shock! Not one O-ring showed any sign of failure. (bearing in mind, that in 24 years of use this unit showed a total of 34000 hours of use, 200 power up cycles, and attenuator actions of **8.6 million**.)

The O-ring kit duly arrived. Out with the attenuator and dismantled with my heart in my mouth!

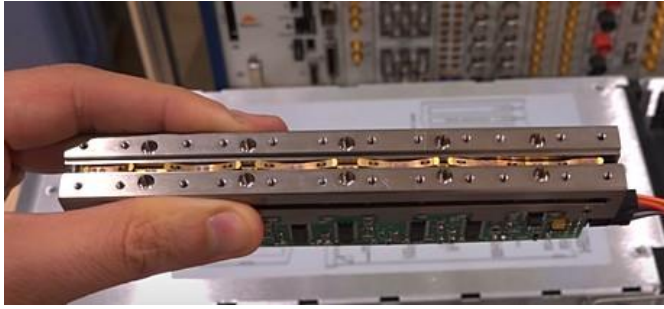
Careful examination of the surface of the gold leaf plated contacts revealed some small oxidation and the odd crud build up. Not daring to breathe and working under a bright magnifying lamp, I cleaned all contacts, then reassembled and tested.

Perfect operation again.
